SAN DIEGO COUNTY WALK AUDIT

Otay Mesa, San Diego

02/29/2024

Otay Mesa Rd between Caliente Ave & Sea Fire Point

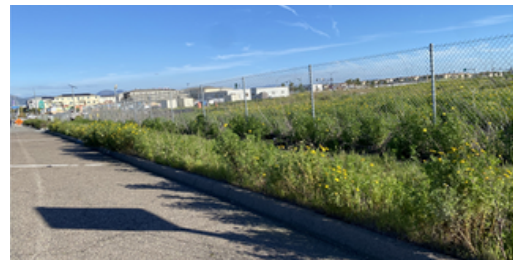
- Otay Mesa Rd is a concern for the community because students from San Ysidro High School walk to and from school through Otay Mesa Rd
- Starting at the corner of Otay Mesa Rd & Caliente Ave and heading toward Sea Fire Point, there are no sidewalks and students are forced to walk on the street

Students walking home from school in the street on Otay Mesa Rd between Caliente Ave & Sea Fire Point

No accessible sidewalk for pedestrians walking on Otay Mesa Rd from Caliente Ave

- Otay Mesa Rd is a popular route that many San Ysidro High School students take to and from school, however, a segment of Otay Mesa Rd does not contain a proper sidewalk

- This segment on Otay Mesa Rd heading towards Sea Fire Point is just an extension of the road and what would be the sidewalk is covered by dense shrubs

- Install a proper sidewalk that connects the rest of Otay Mesa Rd to Caliente Ave
- Adding traffic-calming measures as vehicles on Otay Mesa Rd approach Caliente Ave
- Repaint crosswalks on the intersection of Otay Mesa Rd & Caliente Ave
